## U-Phos® HiFlo System

### Technical Bulletin: Thermal Fuse Cleaning and Verification of Proper Operation

Service Frequency: Every 20 hours of operation

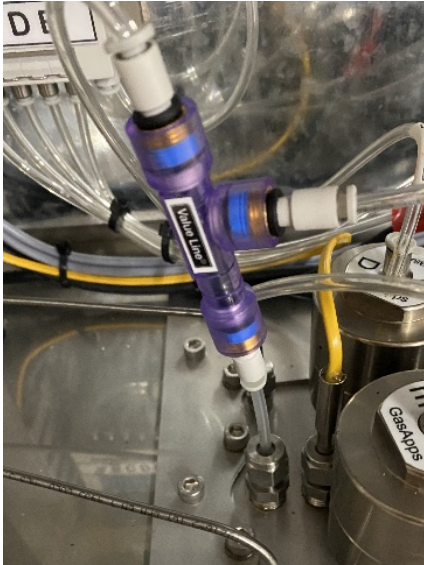
**Venturi Valve  
Attached to Fuse**

12. Section Recap: Ensure line is fully attached and engine block nut is tightened.

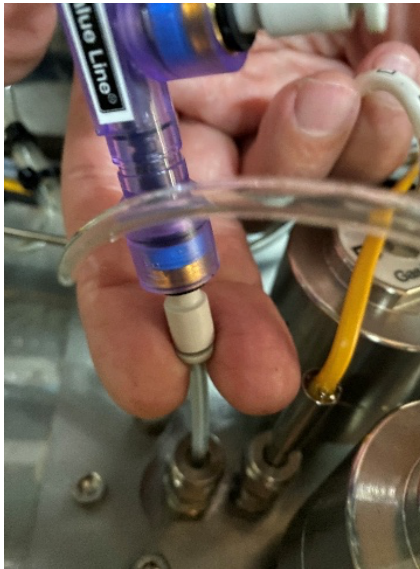
**Releasing Venturi Valve**

1. Carefully support the Venturi Valve body and at the bottom, carefully push the tab using two fingers upward allowing you to slowly pull the housing off the line going into the engine block.

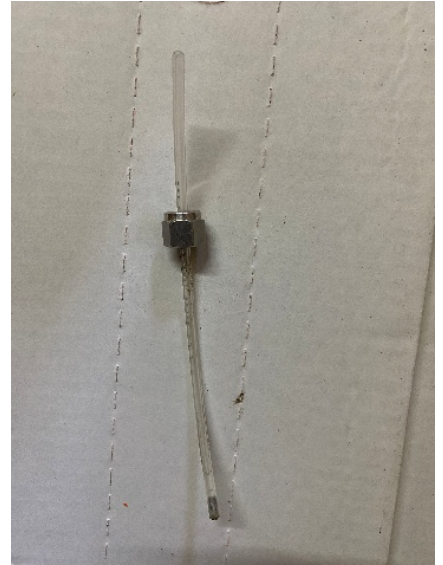
**Removed Fuse**

2. This should leave the line going into the engine block with approximately 1-2 inches of tubing visible.
3. Using a 15-millimeter wrench, loosen the nut going into the engine block and carefully further loosen with your fingers.

4. Once loose, slowly pull the nut upward and the line will also come out.
5. With a moist rag, wipe line off and inspect for damage.
6. If the line is intact and no damage is noted, it does not need further attention.
